FACULTY OF ARCHITECTURE AND ENGINEERING
DEPARTMENT OF CIVIL ENGINEERING

PROFESSIONAL PRACTICE **JOURNAL**

PROFESSIONAL PRACTICE APPROVAL FORM

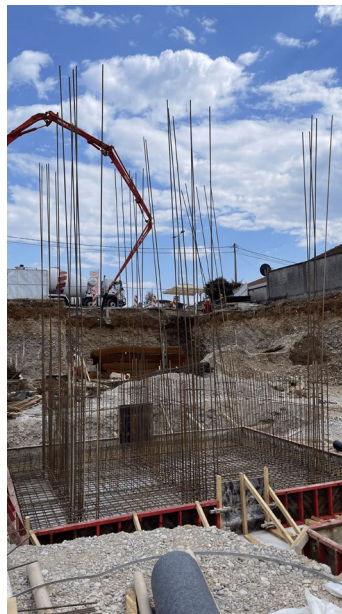
Figure 3 - Elevator Foundation

According to the design specifications, as seen in *Figure 3*, reinforcement was constructed for the elevator foundation and oil separator. Steel bars were positioned and connected throughout this procedure to give both components the structural support they required. To support the upcoming concrete pour, proper alignment and anchoring were made sure of.

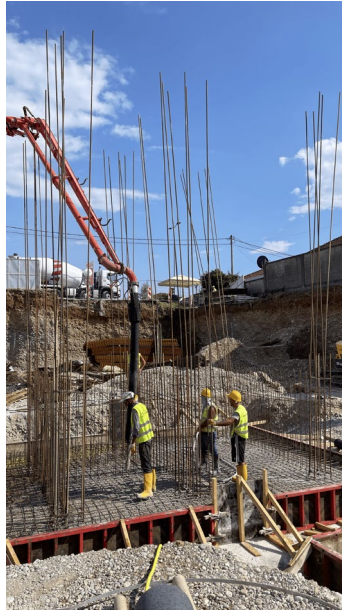
Figure 5 - Concrete pouring for the Elevator Foundation

Seen in *Figure 5*, concrete was poured into the prepared formwork for the elevator foundations and oil separator. The concrete was thoroughly mixed, transported, and placed to ensure uniformity and strength. The surface was finished to meet design specifications and allow for proper curing. A cross section of the elevator is shown in *Figure 6*.

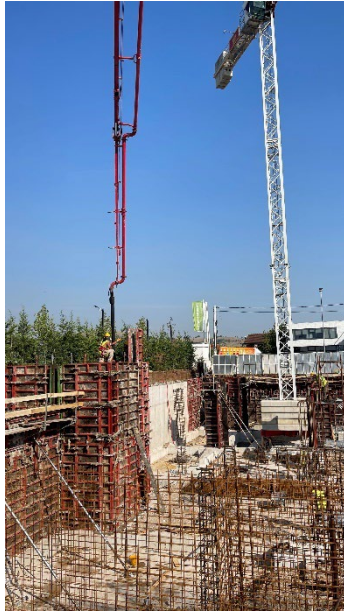
Figure 8 - Concrete Pouring for Specified Walls

Concrete was poured into the formwork for walls POS Z-J, POS Z-7-2, POS Z-6, and sections of walls POS Z-L and POS Z-K as seen in *Figure 8*. The concrete mix was prepared and transported to the site, then placed and finished to achieve the desired strength and surface finish. Proper curing procedures were followed to ensure optimal concrete properties.

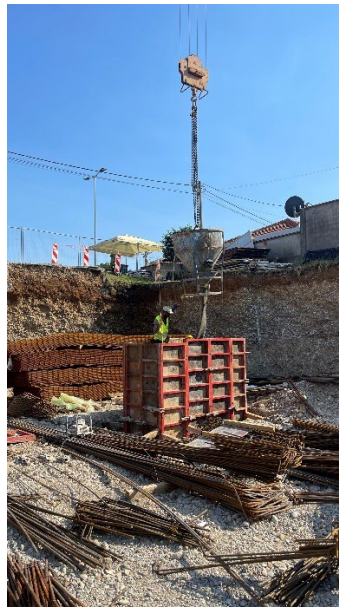
Figure 10 - Concrete pouring for Oil Separator Walls

The oil separator's walls were constructed using the proper concrete mix and methods, as shown in *Figure 10*. The durability and functionality of the walls were ensured by pouring the concrete into the formwork and finishing it to the necessary specifications. To ensure the walls performed and had the appropriate strength, the curing process was watched closely.

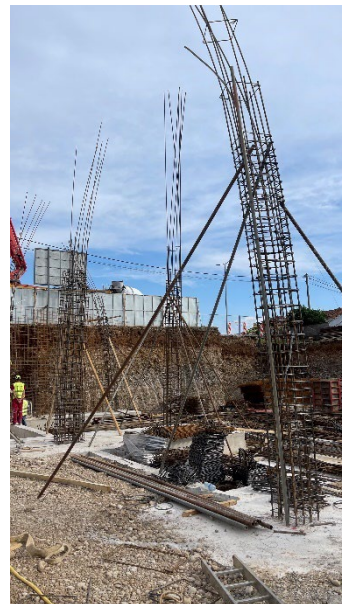
Figure 12 - Reinforcement of Columns

We focused on a number of important jobs requiring formwork, reinforcing, and concreting for the building structure today at the construction site. First, the carpentry brigade had to install formwork and reinforce the columns and walls, particularly where the separator and elevator were located, illustrated in *Figure 11*. From the foundation to the POS100 slab, we installed the formwork and put together the wall and column reinforcements as seen in *Figure 12*. This arrangement guarantees that these crucial locations are both structurally strong and prepared for future development.

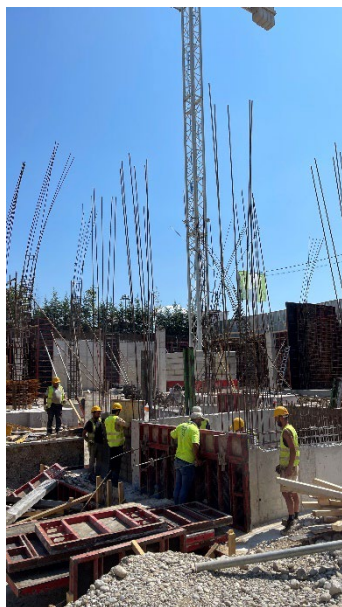
Figure 14 - Parapet Wall

We began with the installation of formwork and reinforcement for the parapet at the elevator location which can be seen in *Figure 14*. This parapet provides lateral stability surrounding the elevator area and serves as a crucial structural element. In order to make sure the structure could support the impending concrete pour, the carpentry team first established the reinforcement of the structure as per the design specifications, and then proceeded to add the formwork around it so concrete could be poured smoothly. To preserve structural strength and design criteria, every reinforcement bar was precisely positioned and secured in place as illustrated in *Figure 15*.

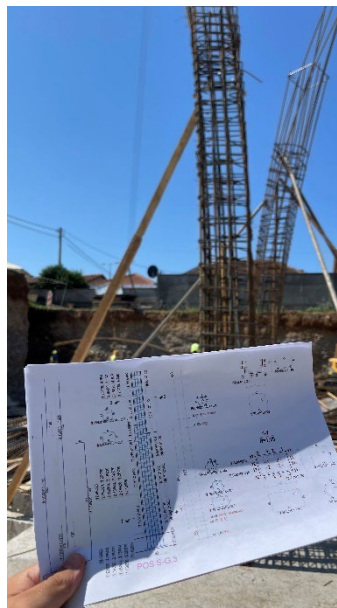
Figure 16 - Checking for proper Design Specifications

The formwork of previously cast portions, particularly the POS Z-L wall and the walls surrounding the elevator, was then disassembled. By removing this formwork, we were able to make room and test the set concrete to make sure it had cured properly and without any problems. During this time, I was also responsible for checking if the reinforcement of the other structural components was put together as per design specifications as shown in *Figure 16*.

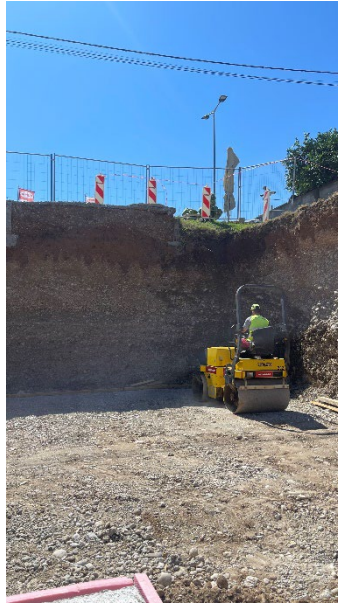
Figure 17 - Roller Compacting the Base Material

Figure 17 clarifies that filling and levelling the area with a compacted base material was one of the day's main tasks. In order to provide a level and strong foundation for current and upcoming building projects, sub-base material had to be carefully spread out and compacted. This layer is crucial for ground stabilization and load distribution, particularly as the building's structural components are added.

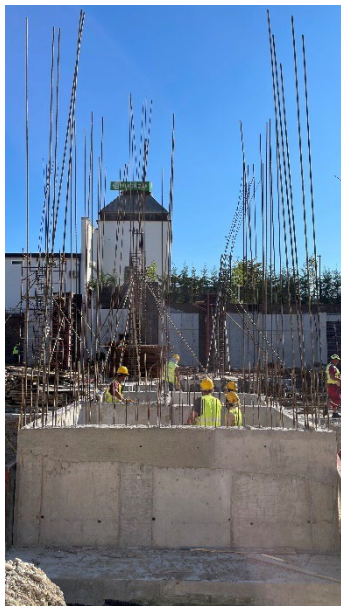
Figure 20 - Parapet Walls after removing formwork

The parapet formwork surrounding the elevator shafts was then disassembled, allowing us to examine the freshly set concrete and get the space ready for further work, as shown in *Figure 20*. Additionally, dismantling made room for the installation of vertical reinforcements in adjacent locations.

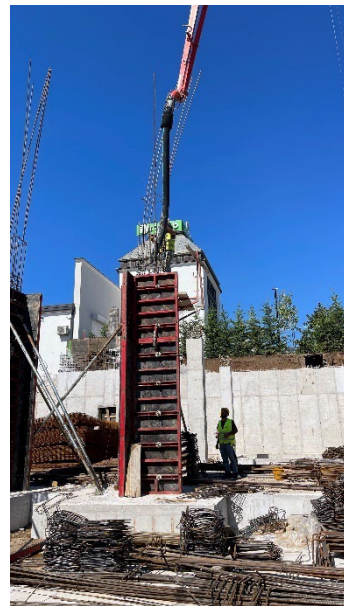
Figure 21 - Concreting the Columns

As seen in *Figure 21*, we then went ahead and concreted certain columns at POS G3, G4, G5, and G7 from the foundation to the POS100 slab. Concrete was carefully poured into each of these columns to preserve alignment and structural integrity, guaranteeing that each section cured with the appropriate load-bearing capability.

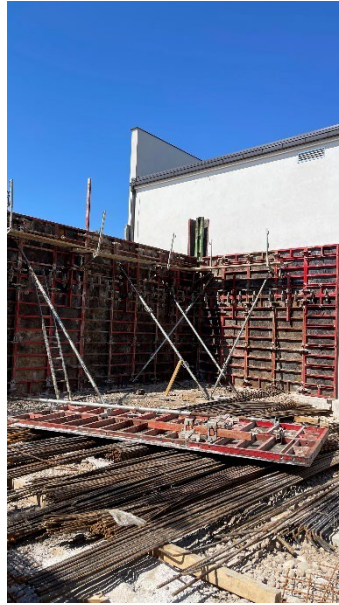
Figure 23 - Formwork of Walls

Figure 23 shows the installation of formwork and reinforcement for the walls and columns from the foundation level up to the slab at POS100 and it received a lot of attention. The formwork, which acts as a mold for the concrete, was meticulously constructed to guarantee that all measurements and alignments matched the design requirements. The reinforcement, which is essential to the concrete structure's strength and stability, was positioned inside the formwork and connected to the steel bars in accordance with the planned arrangement. This procedure guarantees that the columns and walls will have the integrity of construction required to support the building's top stories.

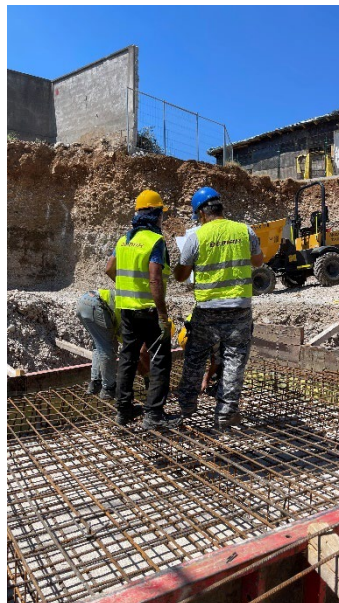
Figure 24 - Formwork and Reinforcement for Elevator POS Tp-3

Formwork and reinforcement for the elevator base were installed at POS Tp-3 in a similar procedure for the lift foundation as illustrated *Figure 24*. Because the elevator's foundation is crucial for supporting its machinery and structure, extra care was taken to make sure that all dimensions, including the exact alignment and reinforcement elements, complied with the design specifications.

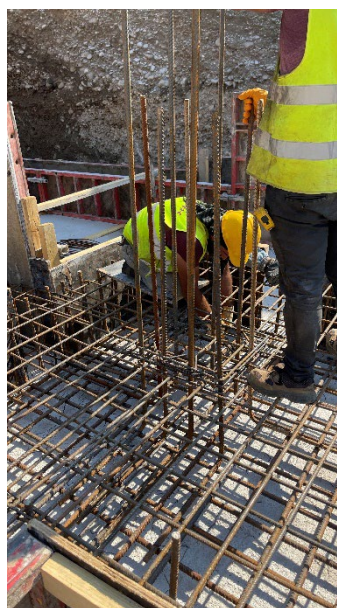
Figure 26 – Brigade Work

Figure 26 illustrates the installation of formwork and reinforcement for the walls and columns from the foundation to POS100 as it was the next task. This work was similar to that done on Day 7, but it continued to focus on getting the structural components ready that will give the building vertical support.

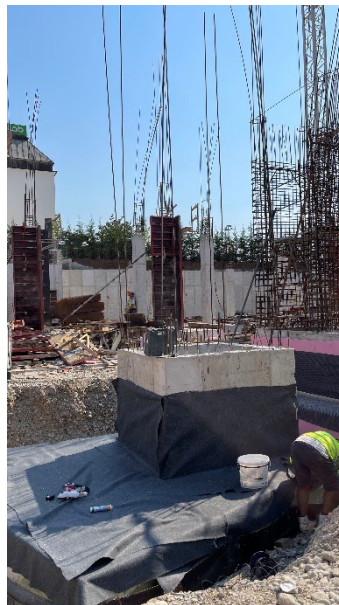
Figure 27 - Waterproofing System

The day began with the installation of the vertical waterproofing system of the elevator shaft, which plays a crucial role in preventing moisture from penetrating the buildings core and it can be seen *Figure 27*. This waterproofing layer was carefully applied along the elevator walls to ensure that no water can seep through, which is particularly important for maintaining the structural integrity and functionality of the elevator system.

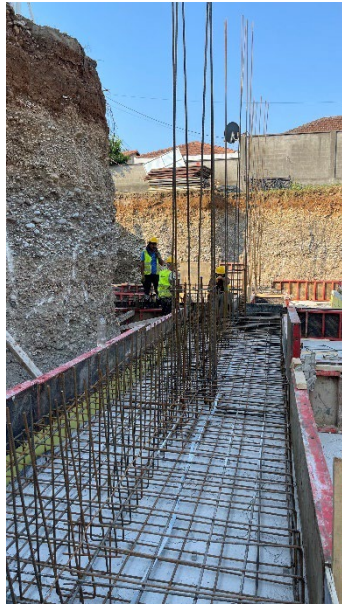
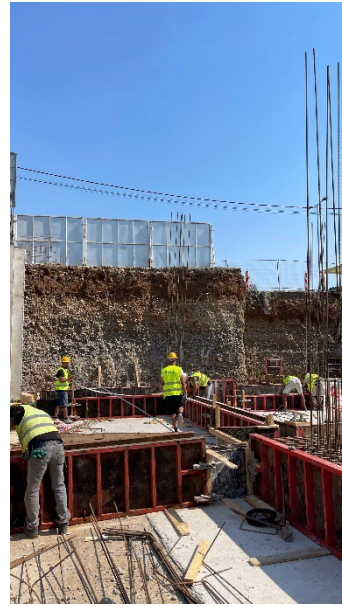
Formwork and reinforcement were also put in place for the connecting beams, isolated foundations, and strip foundations, illustrated in *Figure 29* and *Figure 30* once the basement walls were prepared. This phase of the foundation construction is essential since these components will support a large portion of the building's weight. The isolated foundations, connecting beams, and strip foundations were all meticulously built to guarantee that they held on to the design guidelines and offered sufficient support for the walls and columns.

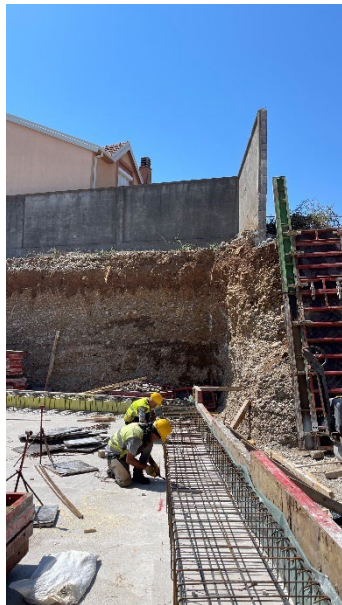
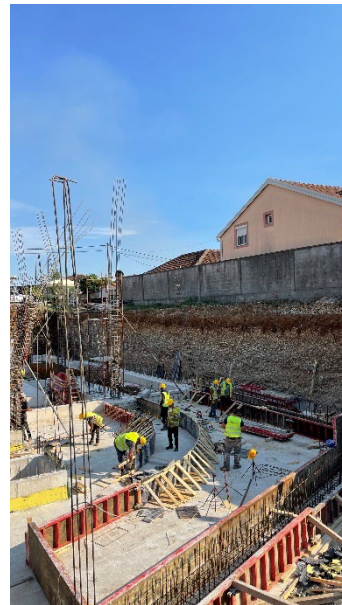
The day began with the installation of formwork and reinforcement for the foundation strips and connecting beams, illustrated in *Figure 31* and *Figure 32*. These components are necessary to ensure that the loads from the superstructure are distributed uniformly across the foundation. In order to satisfy the design requirements, the formwork was meticulously assembled, and the reinforcement bars were positioned properly. For the foundation's components to be strong and stable, formwork and reinforcement must be installed correctly.

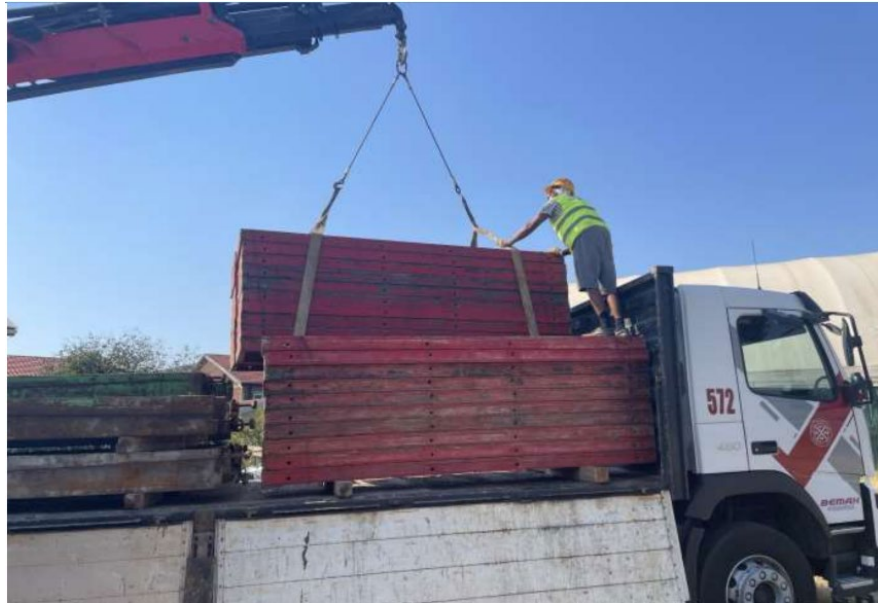
Figure 33 - Transportation of Materials

The shipping and unloading of the necessary equipment and reinforcement also took up a large portion of the day, seen in *Figure 33*. This required cautious delivery of the required construction equipment and steel reinforcement to the location. In order to avoid delays in subsequent building phases, the team made sure that all items were appropriately unloaded and stored in a secure and orderly manner. Maintaining the building project's timeline depends on the timely delivery of materials.

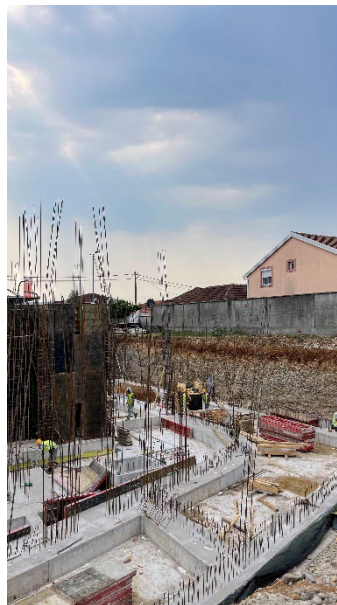
Figure 35 - Connecting Beams and Strip Foundation after being concreted

The workers at **BEMAX d.o.o. Podgorica** focused on taking down the formwork from finished foundation components and continuing to get ready for the next stage of the wall construction on Day 14 of my internship. The day started with the formwork being taken down from the foundation. The following step was to carefully remove the formwork, which had been there long enough for the concrete to harden. To prevent any harm to the freshly cast foundation components, the formwork was carefully disassembled. The foundation pour was finished when the formwork was removed, exposing the concrete that would eventually serve as the building's structural base. A photo of how the structural elements look like afterwards can be seen in *Figure 35*.

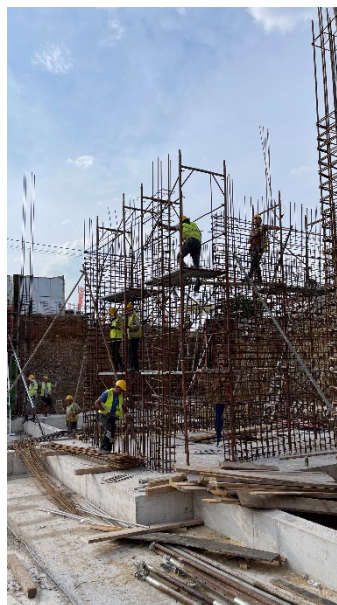
Figure 36 - Reinforcement work

In the meantime, work turned to constructing reinforcement and formwork for the upcoming wall panel segment, which would reach the POS100 floor slab. The reinforcement work is shown in *Figure 36*. To get the exact measurements called for in the design, the carpentry brigade carefully aligned the formwork. In order to provide the required structural strength to support the building's load in the next phases, steel reinforcing bars were inserted within the formwork. This phase is essential to guaranteeing the structure's stability and longevity.

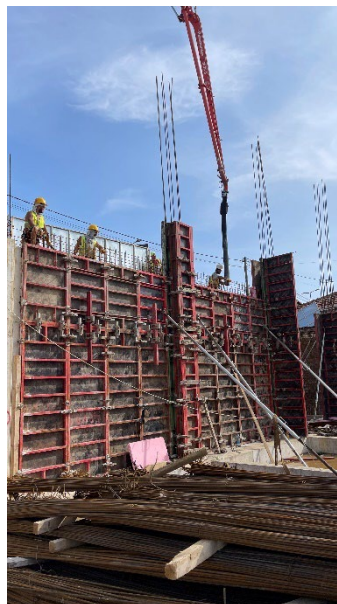
Figure 37 - Concreting the Wall

Additionally, the day's work involved pouring concrete for certain wall and column portions, such as the POS Z-D-1 and POS Z-2 walls, as shown in *Figure 37*, and column POS S-B,2. The concrete was carefully placed and compacted during the pours, which were completed up to the POS100 floor slab. Since these walls and columns are essential load-bearing components, this action represented a critical milestone in the building's structural evolution.

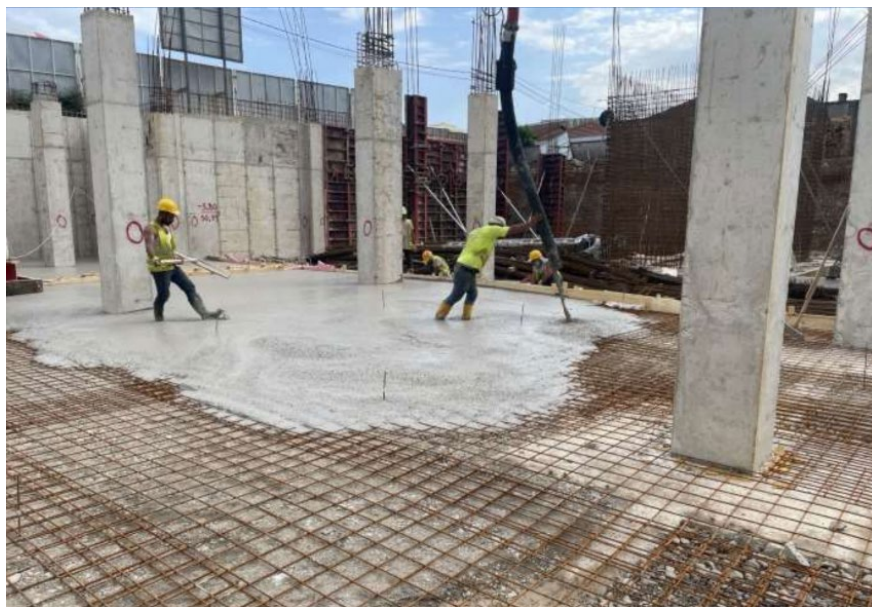
Figure 38 - Concreting the Garage Slab

Figure 38 illustrates the pouring of the garage floor slab. It was the first concrete task that took priority. This slab, which covered 650 m², needed to be precisely levelled and compacted in order to produce a smooth and long-lasting finish. An important step in getting the garage ready for future growth was the timely and effective completion of the concrete pour.

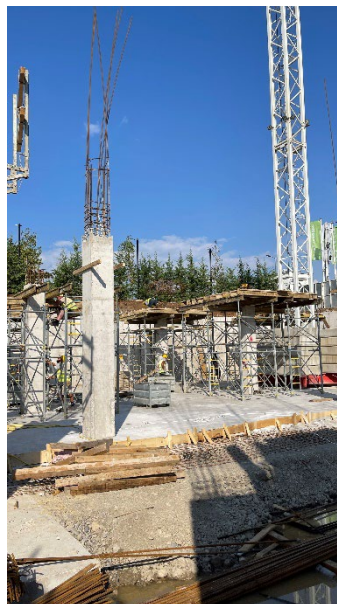
Figure 39 - POS100 Floor Slab Formwork

In parallel, the team started assembling the POS100 floor slab formwork which is shown in *Figure 39*. This work is necessary to provide a flat, sturdy surface that will act as the building's foundation for the subsequent phase of construction. In order to prepare for the concrete pour, the formwork for the slab was carefully measured, installed, and reinforced with bars.

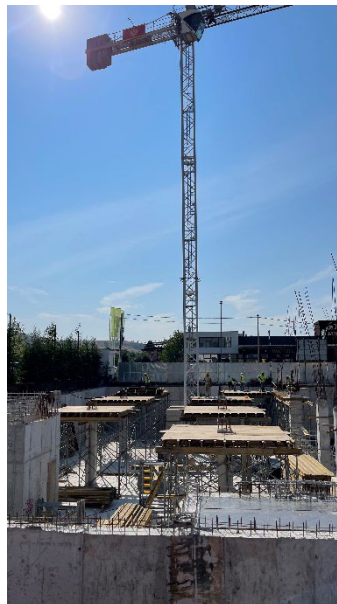
Figure 40 - Formwork of POS100 Slab

The day started with the carpentry brigade continuing to work with the formwork of the POS100 Floor, making further progress in the construction phase. Finishing this formwork would be a crucial step, as we could further proceed with the next level of the building.

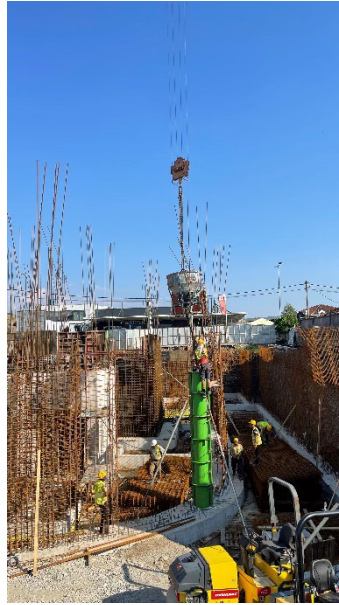
*Figure 41 - Concreting Column S-7**

The brigade continued with the reinforcement work of other structural elements, as well as concreting the round column S-7*, which is visible in *Figure 41*. This would sum up the works of day 18.

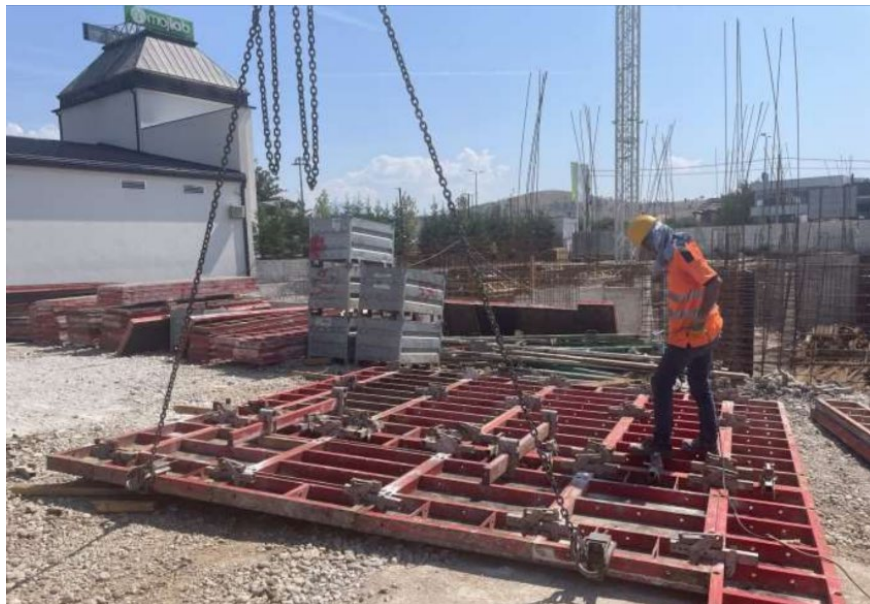
Figure 42 - Disassembly of Formwork

Formwork was removed from columns and wall panels to start the day. To prevent causing damage to the concrete surfaces, this work required accuracy and caution. After being demounted, the formwork was inspected, cleaned, and ready to be used again in later stages of construction. This process can be seen in *Figure 42*.

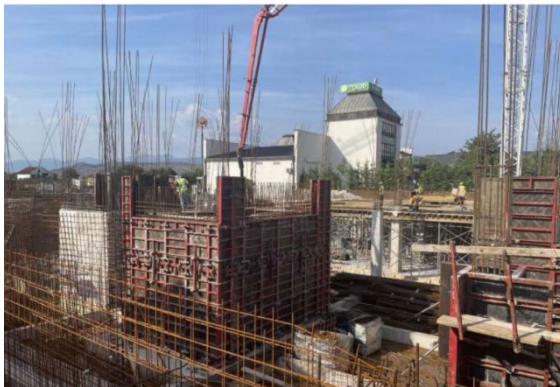
The concrete pouring for several wall panels, including POS Z-3, POS Z-3*, POS Z-C, and POS Z-E-1, up to the POS100 floor slab, marked the end of the day's labour. During this phase, 24.5 m³ of concrete was poured. The structural elements can be seen in *Figure 43* in real life, and in *Figure 44* as AutoCAD drawings.

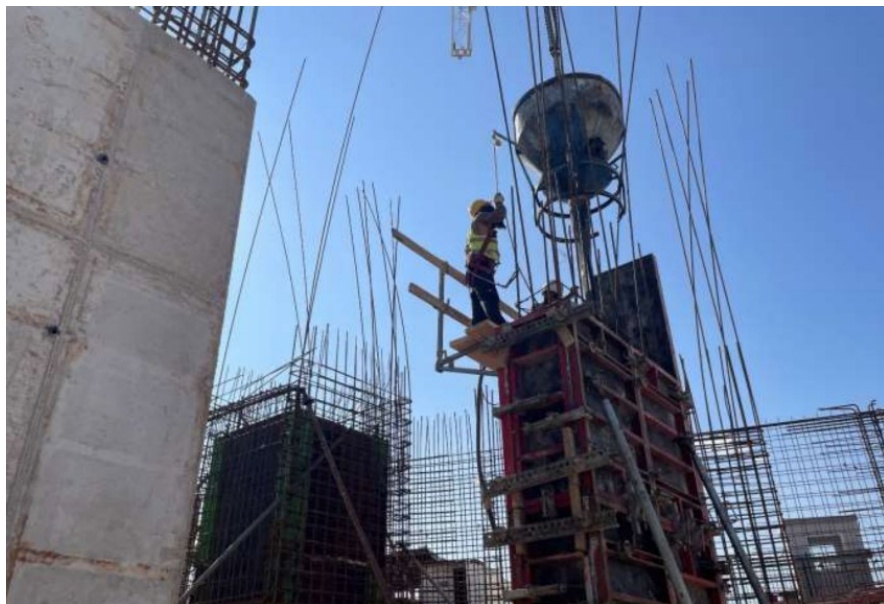
Figure 45 - Concreting Wall Panel POS Z-E-3

As all of the necessary formwork was completed, the brigade concreted the POS Z-E-3 wall panel, which extended up to the POS100 Slab. A total of 4.5 m³ concrete was poured, with the process being closely watched. This process is illustrated in *Figure 45*.

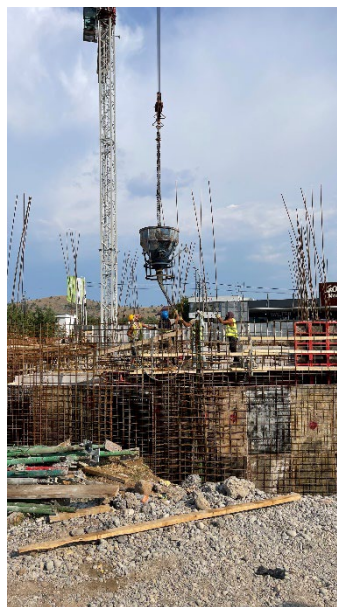
Figure 48 - Concreting Wall Section POS Z-B-8

The day concluded with the pouring of concrete for the POS Z-B-8 wall in the basement, using 5.0 m³ of concrete, and it is illustrated in *Figure 48*.

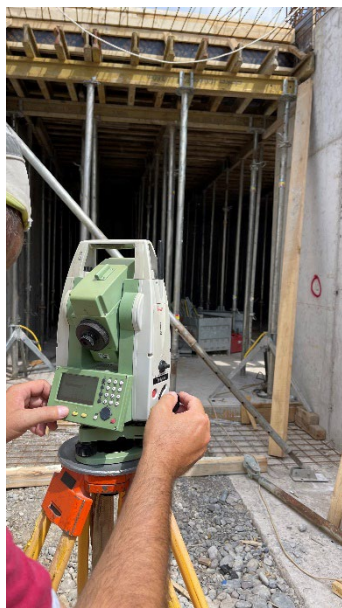
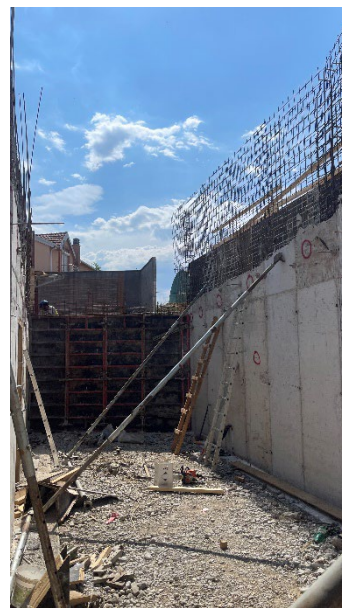
This was very interesting to me as I was prepared for this from my university course, Surveying, which we did in the 4th semester. We spent almost half a day conducting measurements for the slope of the ramp, as it had to be reinforced and concreted with high precision, as well as meeting the design specifications. We labelled these measurements with points, as shown in *Figure 52*. These measurements played a crucial role in maintaining the structural accuracy of ongoing and upcoming work.

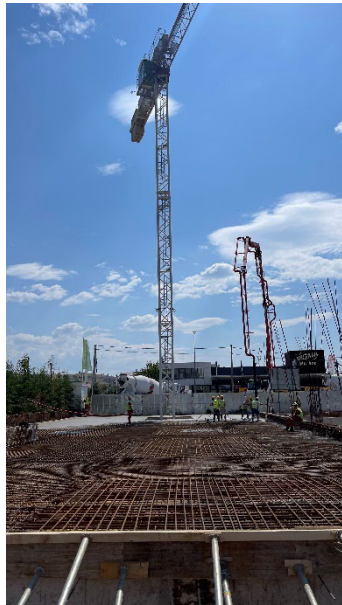
Figure 53 - Before Concreting Slab POS101-2

During this day 176.5m³ of concrete were poured for the slab POS101-2, which is 25cm thick. This process was highly supervised as it took half a day for all of the concrete to be poured and vibrated. All necessary engineers were gathered watching this process. It was monitored closely to ensure uniform placement and compaction of the concrete for the structural strength. *Figure 53* and *Figure 54*, shows the process before and after being concreted.

The crew made progress on the formwork and reinforcement installation for the slab and beams of POS101-2 in parallel with these operations. Accurate component alignment was necessary in this crucial step to guarantee stability and appropriate load distribution.

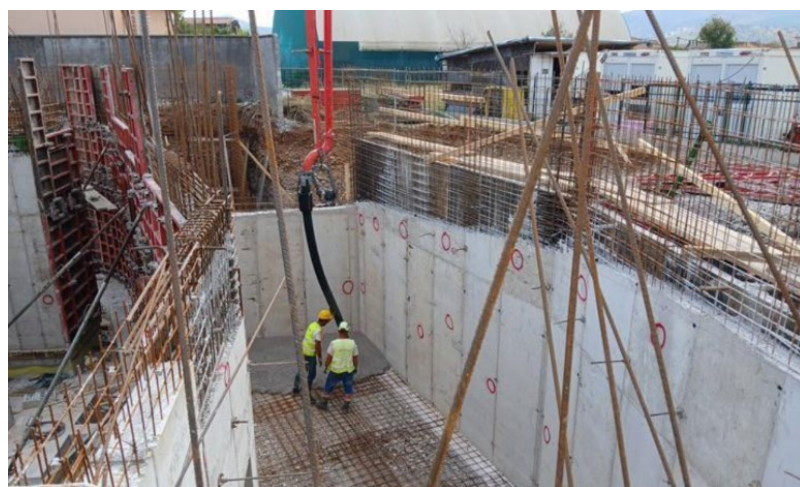
Figure 55 - Floor slab concrete pouring

Additionally, there were three concrete pouring tasks during the day's operations. Using 10.0m^3 of concrete to pour a floor slab that is 50m^2 in size and 20cm thick. This work was completed effectively to provide a strong foundation for the building above. The process is shown in *Figure 55*.

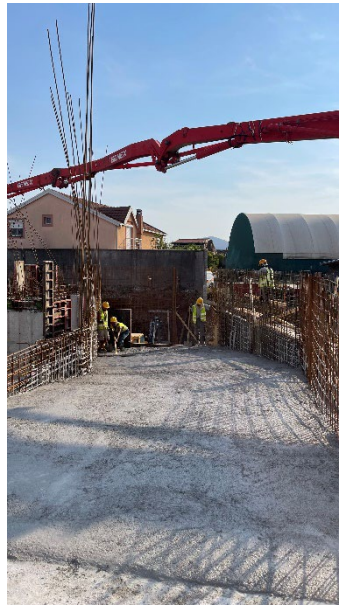
Figure 57 - Concreting Slab POS101-4

During this day, a total of 26m^3 of concrete was poured. 12m^3 of concrete were used for a basement wall, reinforcing the structural framework, while 14m^3 of concrete was used for the slab POS101-4, which was the ramp slab, creating a sturdy floor level to support the superstructure above. The activity can be seen in *Figure 57* in real life, and in *Figure 58* as an AutoCAD Drawing.

In order to support the forthcoming concrete pour, the team assembled the steel reinforcement for slab POS 101-4 as part of additional reinforcement work.

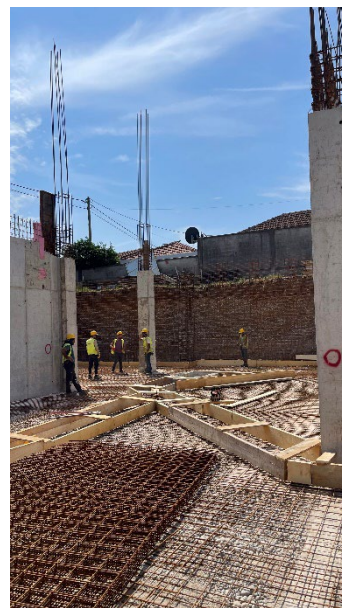
Besides the measurements for the tube passings, we also conducted some measurements so the carpentry team knew how high the garage floor should be concreted. We noted this points with red circles and they were 1.20m from the current floor, as shown in *Figure 59*. The carpentry brigade knew the thickness of the floor slab was 20cm, so they poured concrete until the height reached 1m from the noted red circles.

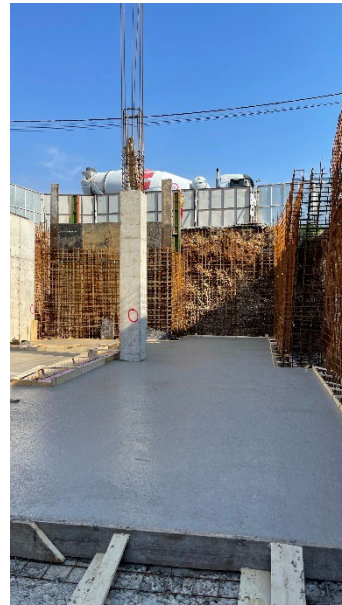
Figure 62 - Levelled Garage floor slab

A total of 87m³ of concrete was poured for the garage floor slab, concluding the floor slab for the basement level. This was supervised by all of the engineers in site as it had to be done according to design parameters. The activity is demonstrated in *Figure 61* and *Figure 62*.

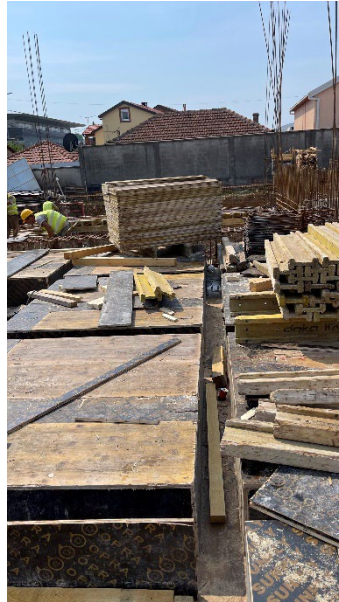
Figure 65 - Preparation works for POS100 floor level

Finally, I got to see the reinforcements and work for the POS100 level being made. It was very sophisticating to see how each element connects with the previous ones that were build. The process is visible in *Figure 65*.
